Minerals Inspection Report

Report Date: 11/18/2013

Mine Name: Asphalt Ridge	Permit Number: M/047/0032	Mine Status: Inactive
Operator Name: Tar Sands Holdings II, LLC	Inspection Date: 11/18/2013	Permit Fees: Delinquent
Inspector(s): April Abate	Inspection Time: 2:00 PM	Bond Amount: \$302,000
Attendee(s): Rick and Annette from Asphalt Ridge	Weather: Clear, 55 F	Bond Escalation: Due
Inspection Purpose: Routine inspection		Prior Inspection: 05/18/2011

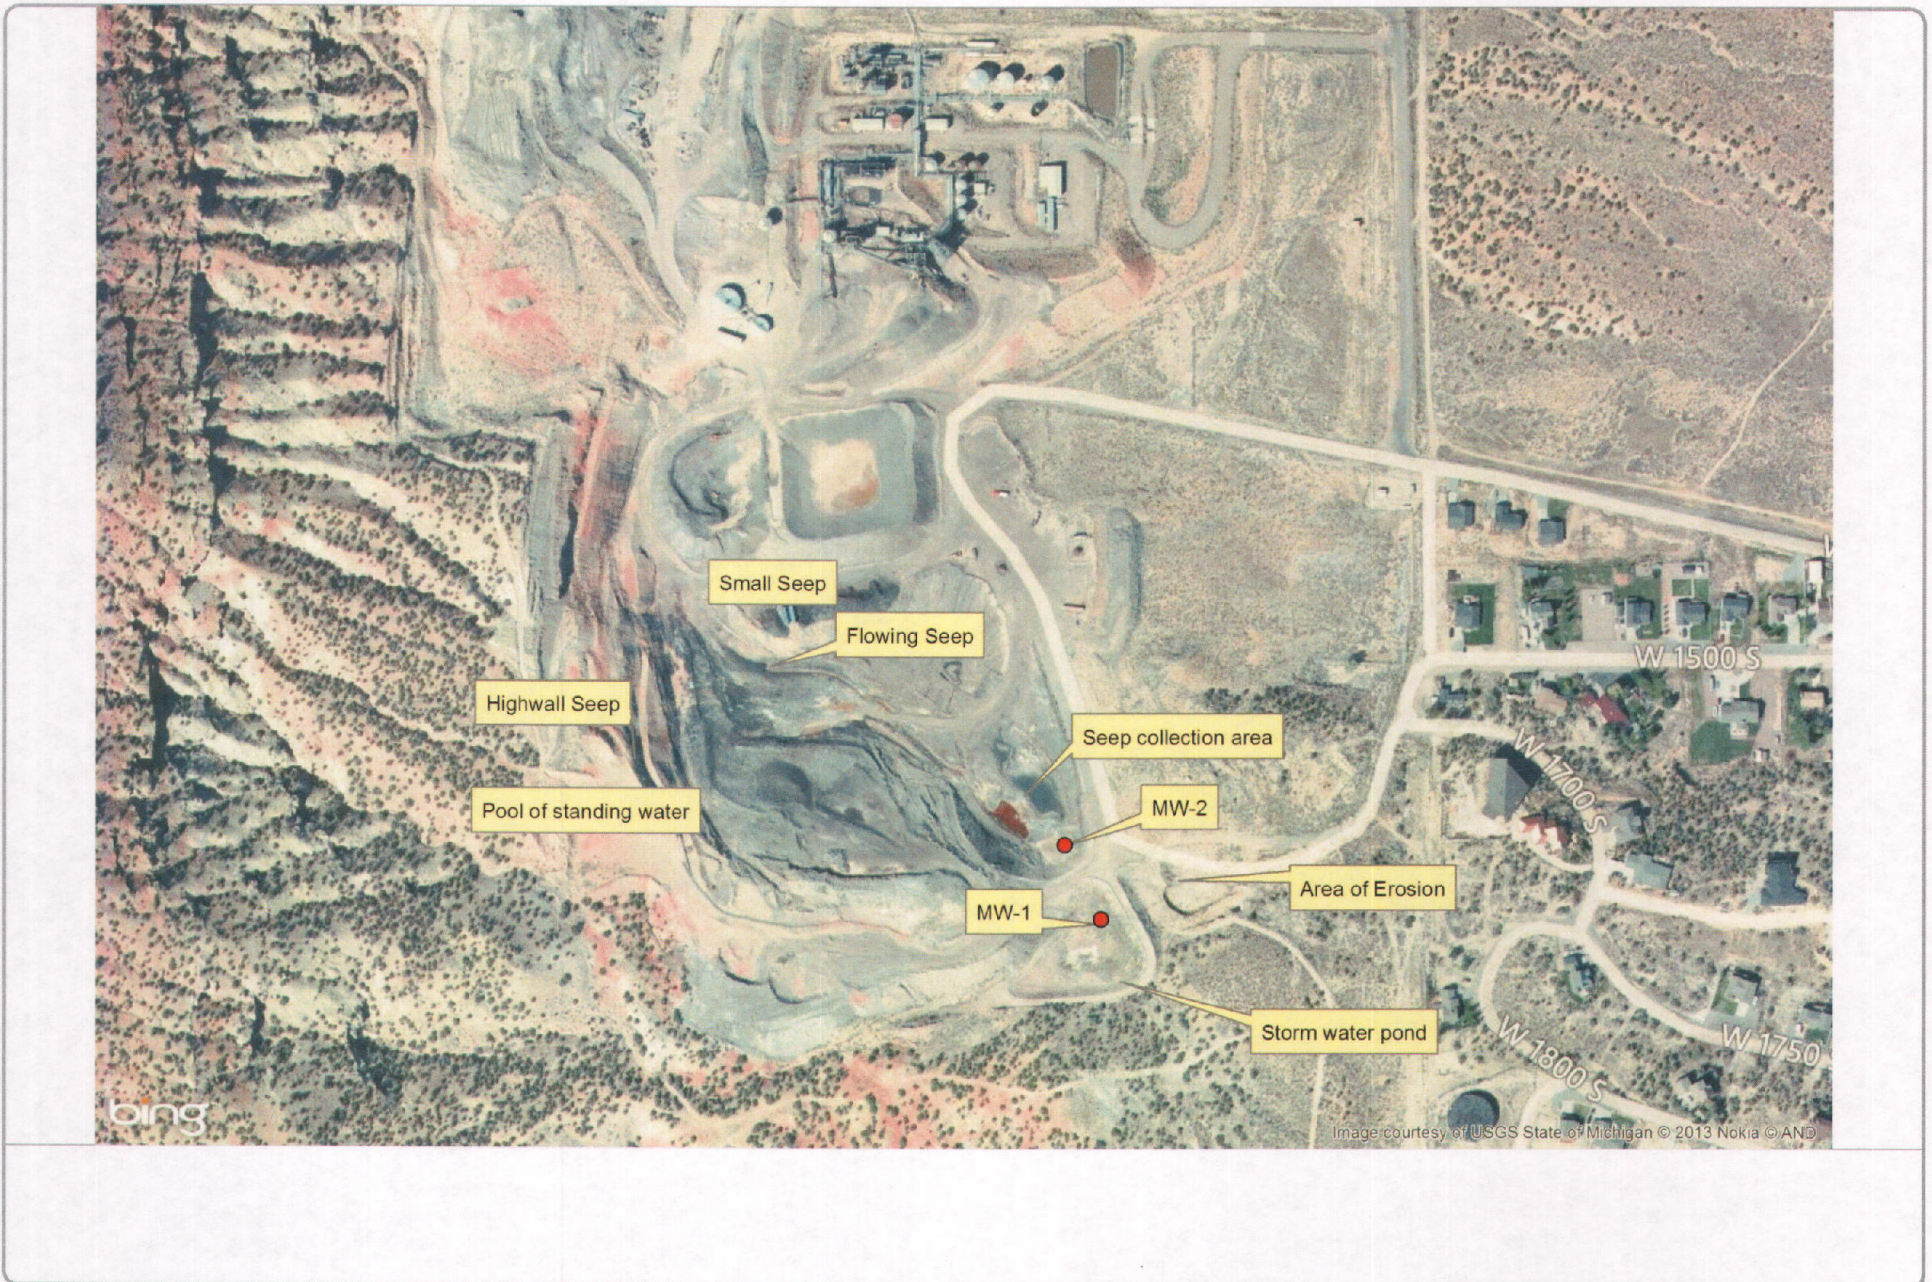
This area represents the boundary between the haul road and the access gate into the property. A large splay of sediment was noted due to unbermed areas.

3. <i>Protection of Drainages/Erosion Control</i>	<input checked="" type="checkbox"/>	<input type="checkbox"/>
Several drainage issues were identified at the site. A seep identified on the west highwall was observed generating a large pool of standing water on the haul road at the base of the pit. Two smaller seeps were identified on the north side of the pit on south facing slopes near the base. At one of the seeps, flowing water was observed. This seep has been labeled on the plan maps. Yellow and red staining was observed from both seeps. Drainage problems were identified at the base of the seeps. Water was not draining properly to the groundwater collection area (near MW-2) leaving a blocked off canal of standing water. Two storm water ponds and MW-1 and MW-2 were located during the inspection. Personnel at the mine were not aware of the last time the monitoring wells were sampled. Drainage from the haul road was flowing down a dirt road that leads to the southeast property gate. Erosion rills were noted along this dirt road and a large splay of sediment was dumped at the bottom of a low spot depression (this depression) did not appear to be one of the designated sediment ponds. Discussed with mine personnel adding berms along the road to prevent sediment from eroding into this area.
